## Use of Fiber Optic in Transformers

### **“FIELD EXPERIENCE WITH MULTIPOINT INTERNAL TEMPERATURE MEASUREMENTS OF CONVERTER TRANSFORMERS”**

Ahmed Glodjo\*  
Manitoba Hydro

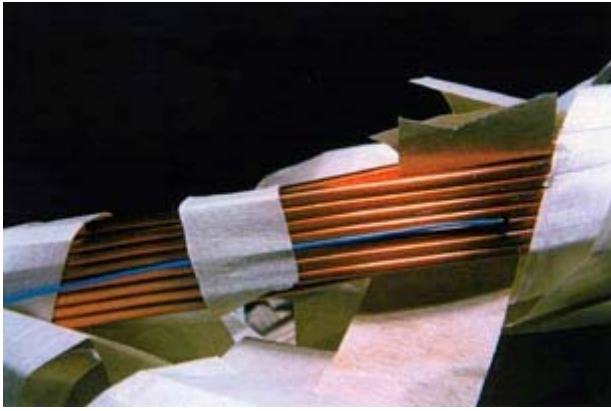
**FIGURE 2: The Probe Tip On The Conductor**

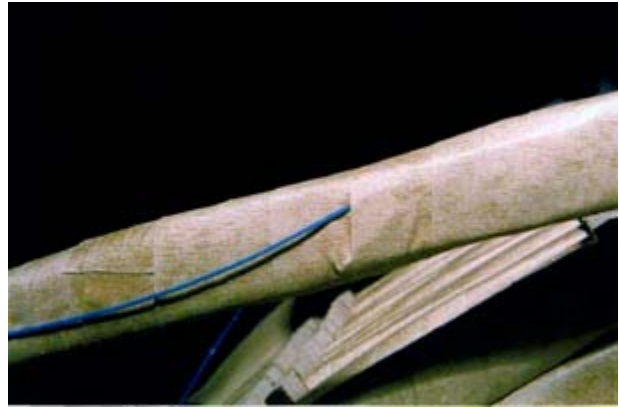
**FIGURE 3: The Probe Tip Covered With Paper**

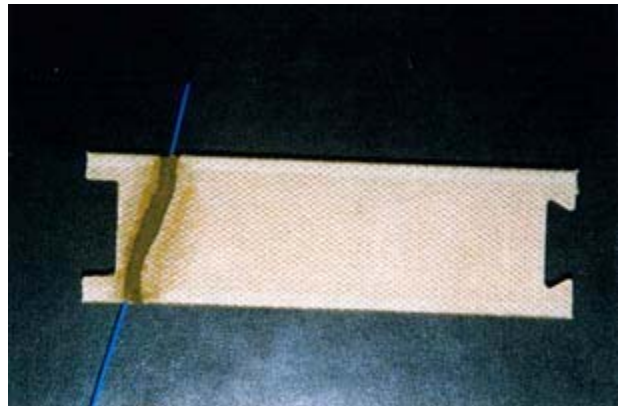
**FIGURE 7: Probe Secured Using a Glue**

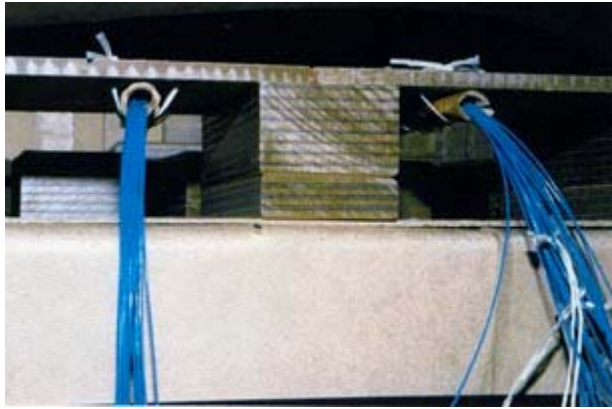
**FIGURE 8: Fiber Optic Exiting Winding**

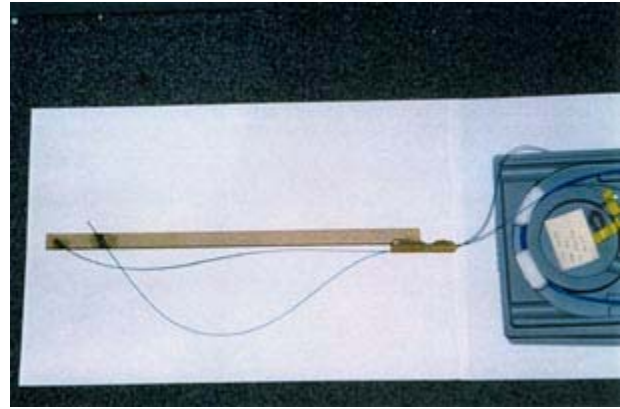
**FIGURE 9: Core Duct Stick With Probes**

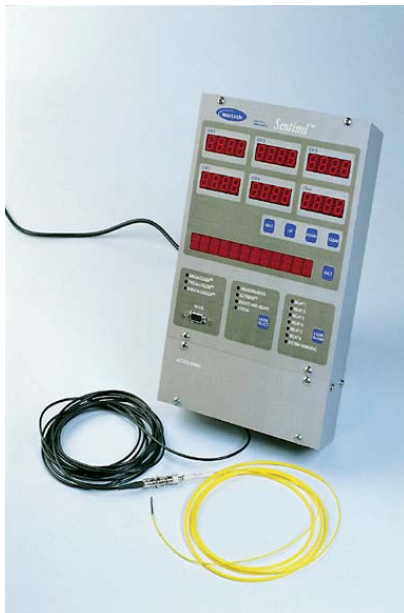
**FIGURE 10: Six Channels Data Logger**

The transformation of the optical signal into an electrical signal is still costly. The expected benefits must overshadow the cost. For this particular reason, we were continuously monitoring only 6 out of 36 probes. These 6 probes were selected as they measure the highest values during the factory load test. The optical connectors interface must be clean; otherwise even fingerprints can prevent the light signal from going through. The instrument for on-line monitoring was a 6-channel data logger shown in Figure 10. The available features are Mega-logger™, Triggered logger and Event logger. The Mega-logger is capable of saving maximum, average and minimum values for every channel for one year. Its analog output module provides connectivity to other monitoring systems. The

remote communication with the unit is also available. The data can be downloaded easily into an Excel spreadsheet format. The trigger and event settings can be used to download the data only after receiving the trigger or event alarms.

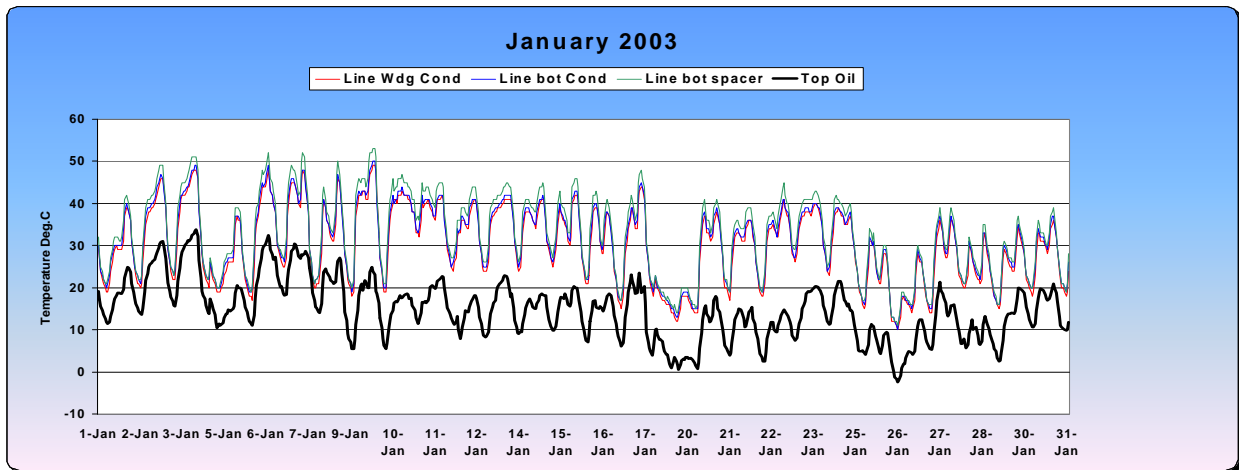
FIGURE 11: Line Winding and Top Oil Temperature Measurements For Month Of January 2003

It is observed, (FIGURE 11 and 12) that there is a very significant difference between the winding temperature and the top oil temperature, more so in January than in July. This raises the questions about the accuracy of the IEEE thermal model which is based on a top oil temperature measurement and simple relationship between this and the hottest-spot temperature.

The IEEE model that bases its calculation on the top oil temperature under overloading conditions underestimates the hottest-spot temperature by taking into account the top oil temperature instead the winding cooling duct and/or conductor temperature. The availability of direct measurements by fiber optic sensors may help to improve the hot spot calculations and therefore the thermal model.

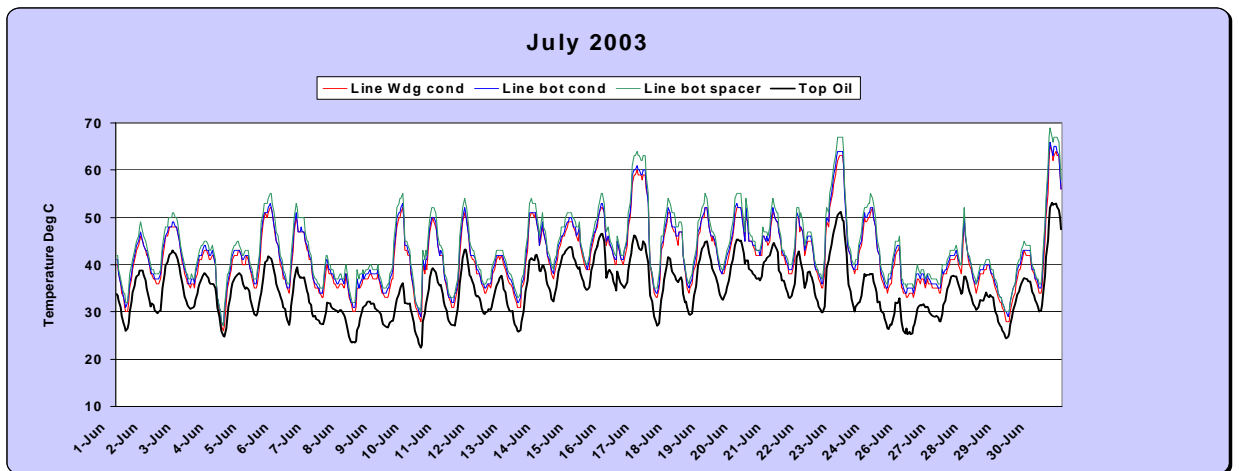
FIGURE 12: Line Winding and Top Oil Temperature Measurements for Month of July 2003

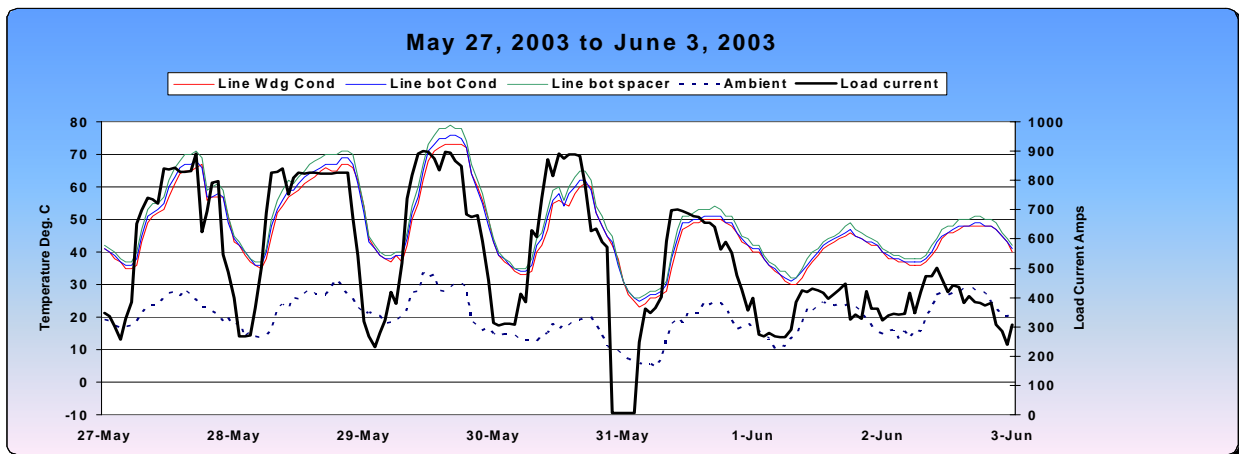
**FIGURE 13: Three Line Winding Temperatures Relationship To Load Current And Ambient Temperature**

The Figure 13 shows dependence of the winding temperatures (light weight top traces) on the load current (heavy trace) and ambient temperature (bottom dotted trace). The transformer was out of service for short time (May 31st) and it was under light load after. There is an obvious dependence on the load current. The contribution of the ambient temperature can be noted on 29<sup>th</sup> of May when for the same load current (approx. 900 Amps) as on 30<sup>th</sup> of May the winding temperature has increased solely due to increase in ambient temperature. The same could be said for the decrease in winding temperature on 30<sup>th</sup> of May following the drop in ambient temperature, while the load current remained at the level of approx. 900 Amps.

As a part of its normal duty, this transformer undergoes significant load variations, as can be seen on Figure 13 for the week of May 27 to June 03, 2003. The load demand fluctuations and the periodic connection of a large synchronous condenser result in a daytime load of typically 0.8 p.u. and night time load of 0.4 p.u. These wide load variations allow for a better evaluation of the dynamic behaviour of the IEEE Guide Winding Hot-Spot Temperature model, based on fiber optic temperature probes measurements.

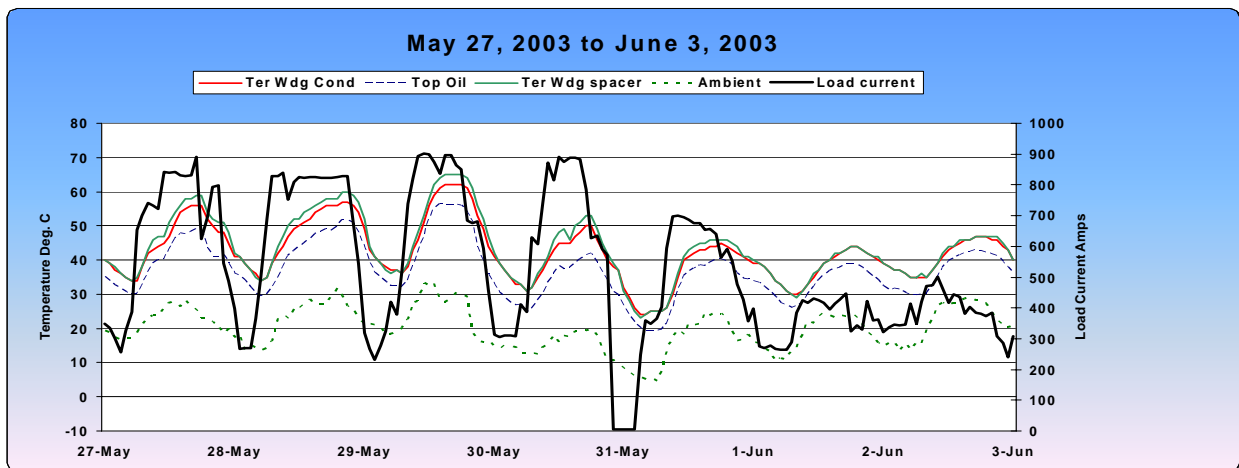
**FIGURE 14: Tertiary Winding Temperature Relationship To Load Current And Ambient Temperature**

The tertiary winding (Figure 14) is running about 10°C cooler than line winding for the same period as Figure 13. The dependence on the load and ambient temperature is similar.

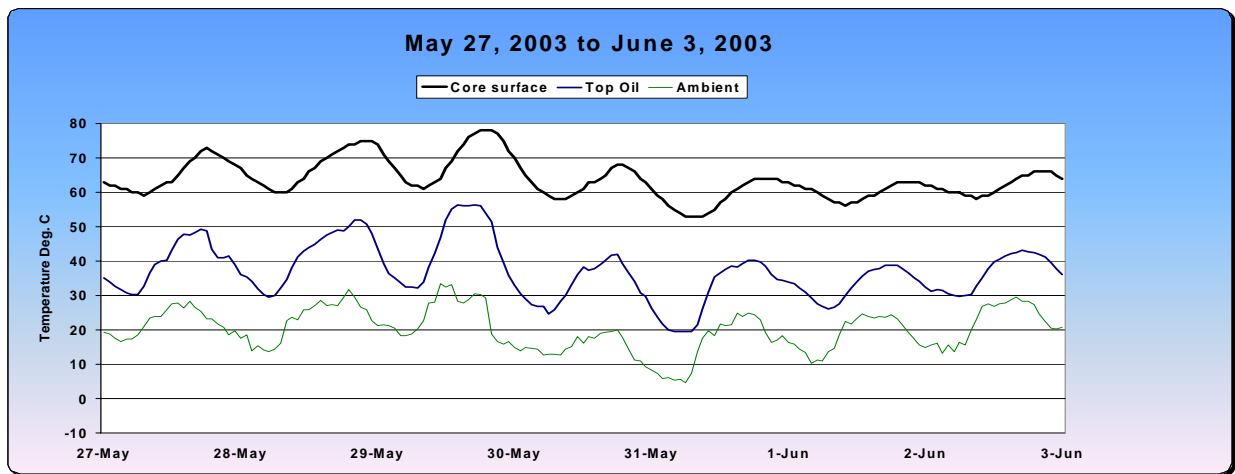
**FIGURE 15: The Iron Core Surface Temperature Relationship to Top Oil and Ambient Temperature**

The Figure 15 clearly illustrates that the iron core surface temperature is much higher than the top oil temperature (middle trace) for the same observation period as in Figures 13 and 14.
